AFML-TR-77-184

ACCELERATED CORROSION OF ADHESIVELY BONDED 7075 ALUMINUM USING WEDGE CRACK SPECIMENS

MECHANICS AND SURFACE INTERACTIONS BRANCH
NONMETALLIC MATERIALS DIVISION

OCTOBER 1977

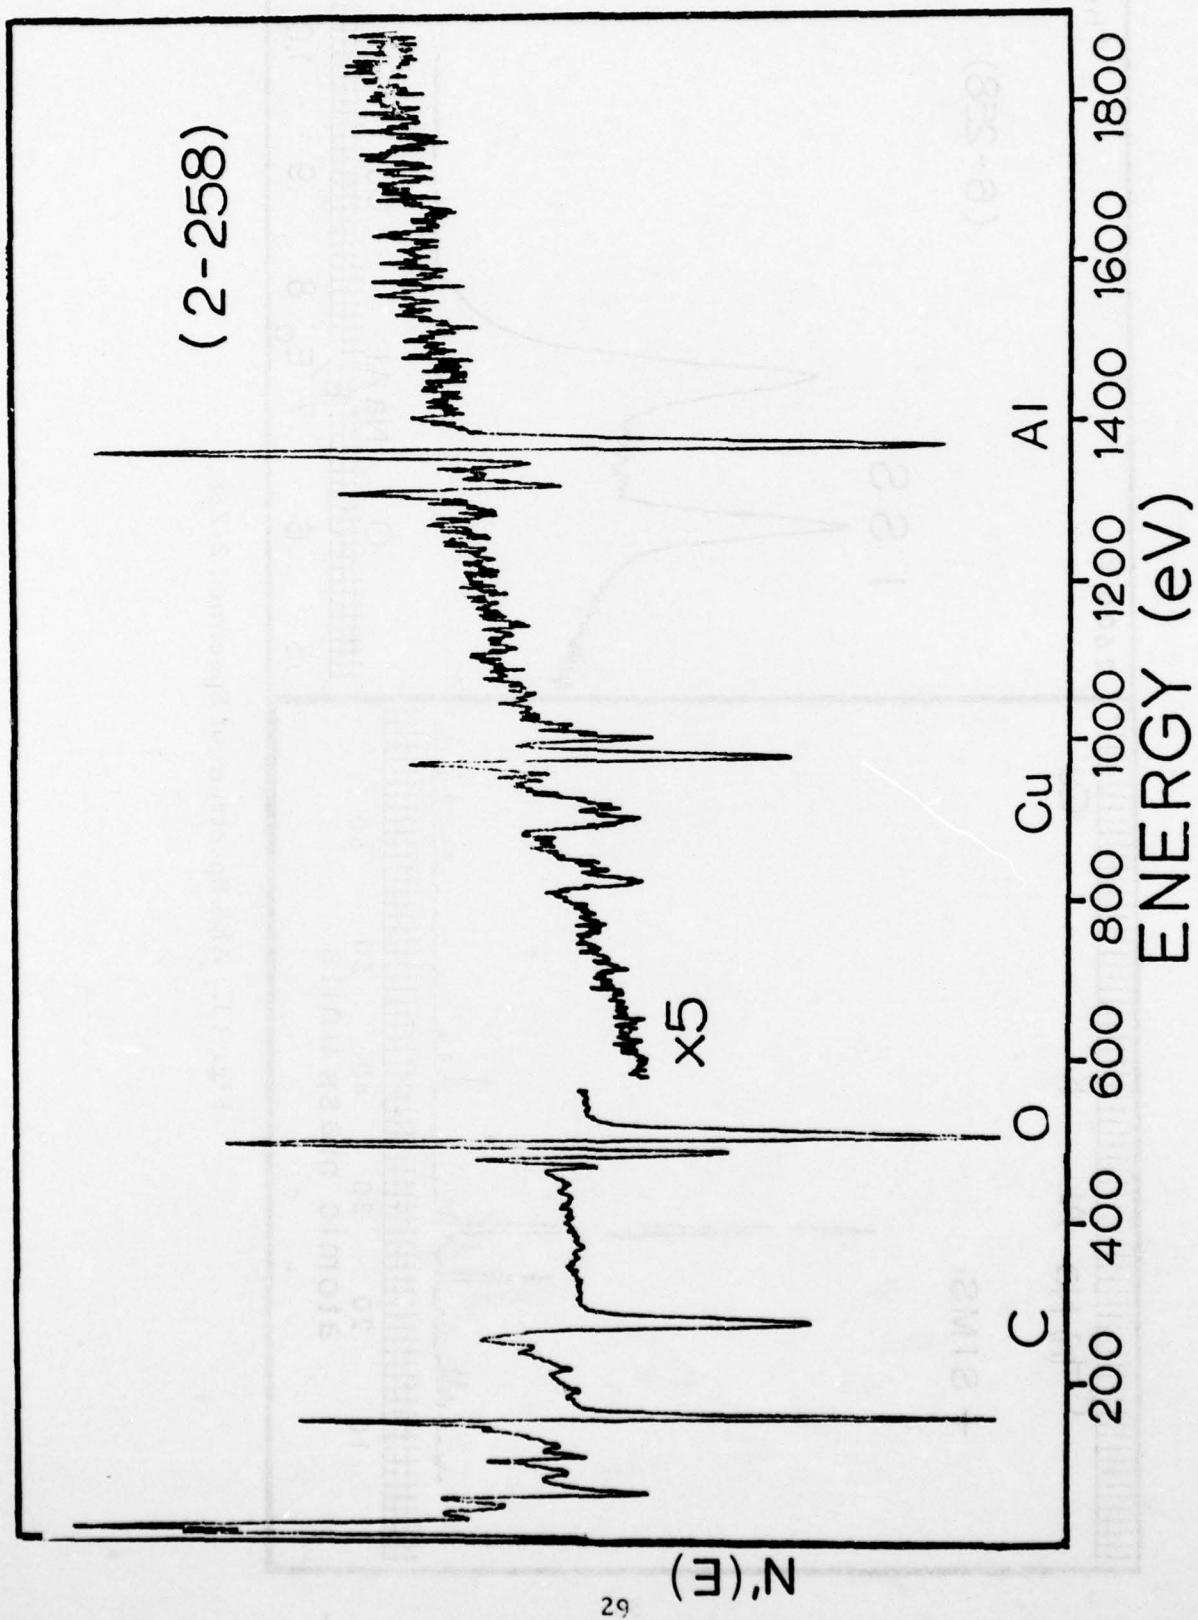
Fig. 12. SIMS-ISS Spectrum of Specimen 2-258.

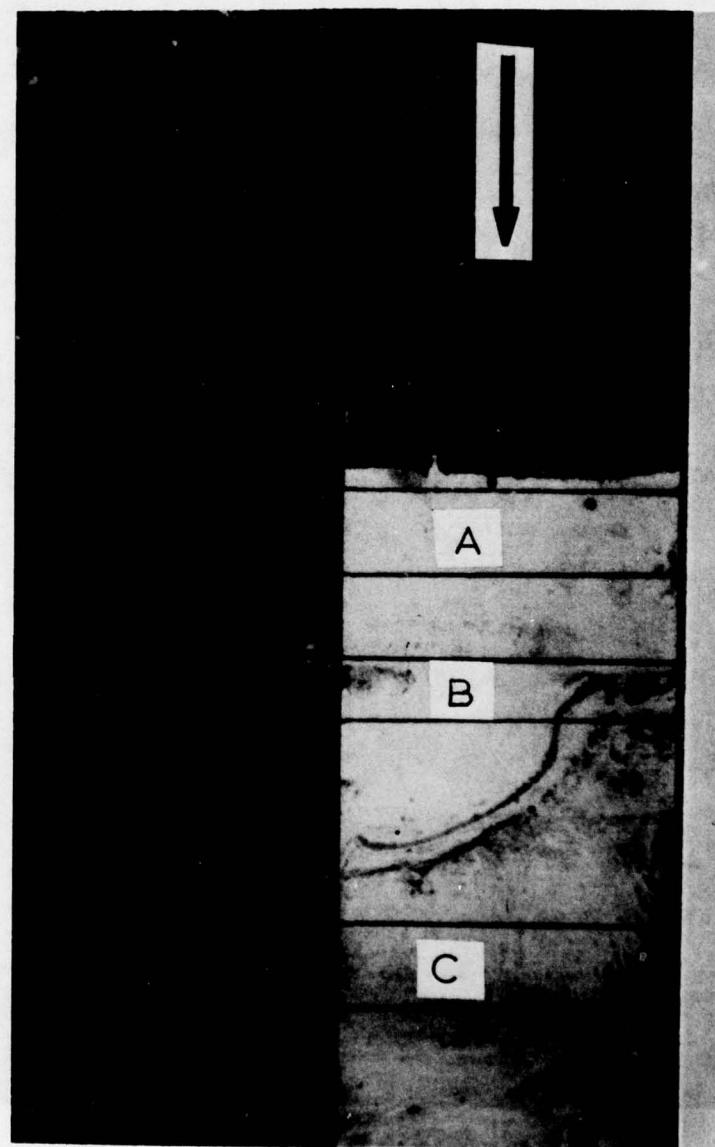
Fig. 18. Sampling Details of Adhesively Failed Wedge Test Specimen 2-258.

Figure 18 shows an adhesively failed wedge specimen. The wedge direction is shown by the arrow. This specimen (2-258) had scotch tape applied to the oxide surface as described previously. The area designated A shows where the tape caused failure. The initial stress from the wedge caused the crack to progress directly through this area and stop at B before exposure to the environment. An Auger analysis of spot A shows heavy carbon contamination and very small intensity peaks from oxygen and aluminum. Analysis of a spot opposite A (adhesive side) showed only carbon.) This indicates the resin never wet the oxide surface due to the carbon layer present from the tape. Once the adhesive (interfacial) failure was established in area A it remained at this interface and when exposed to the # 258 environment the failure continued through B to C. Figures 12 and 13 show the spectral data obtained from this specimen using a sample from area B. Carbon, copper and a normal amount of oxygen and aluminum were found in this area. Analysis of a spot opposite B (adhesive) shows a small amount of oxygen and aluminum indicating the resin did wet the oxide in this area. An analysis of spot C shows qualitatively the same elements as detected from sample B.

Samples were obtained from all of the adhesively failed specimens in the same manner as shown in Figure 18 and described in the previous text. The data shown in Table 3 qualitatively represents the average for all of the other specimens analyzed. Sodium and potassium are detected by SIMS on a number of specimens; however, it is difficult to determine its origin since it is prevalent in most solutions, and handling the specimens can be a source of sodium even when care is taken. Calcium is most notable in the SIMS data when there is fluoride in the pickle solution. Magnesium and copper are found in the Auger data for failed specimen P_A-258, while fluorine, magnesium, copper, and zinc are found on the failed surface of P_B-258. Matrix test specimens 2 and 6 were pretreated with pickle solution A and the failed surfaces of 2-258 and 6-258 both have detectable amounts of copper present; however, magnesium is not detected. Matrix test specimen 18 was pretreated with pickle solution B and magnesium copper, and zinc are detected, primarily by Auger analysis, on specimen 18-258.
